# Experimental and Simulation Analysis of Electrical Breakdown for 220kV Silicone Rubber Pre-Molded Cable Joints

Tong Liu, Baojun Hui, Mingli Fu, Shuai Hou, Bing Luo, Guoli Wang  
Electric Power Research Institute  
China Southern Power Grid

May 2017

**INSUCON**  
2017

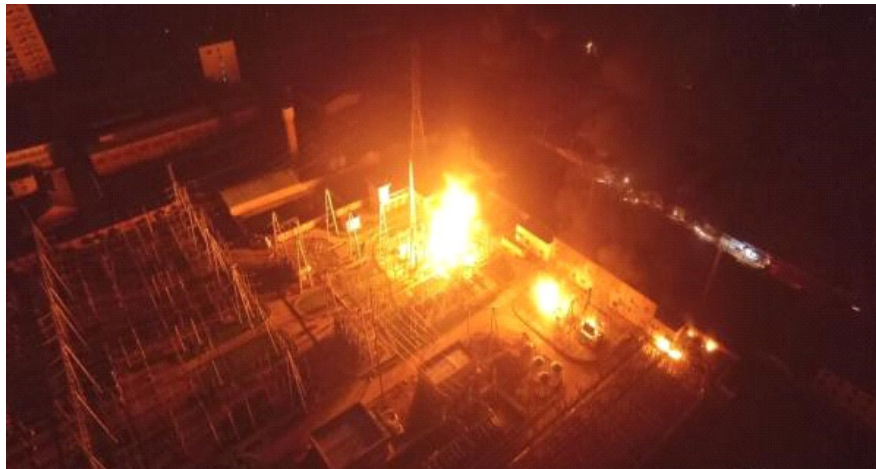
Fire in cable trench of 330kV substation, 18 June, Xi'an

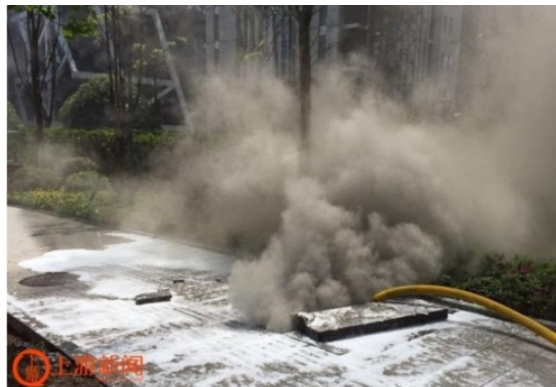
Fire in 220kV cable tunnel, 22 August, Chongqing

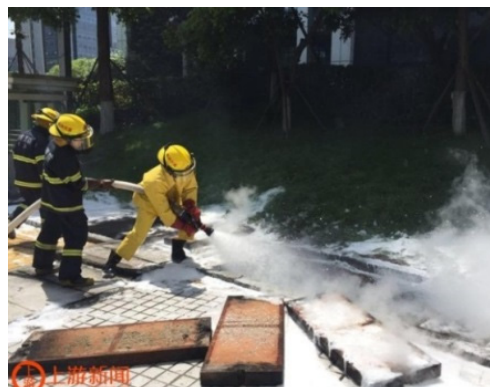
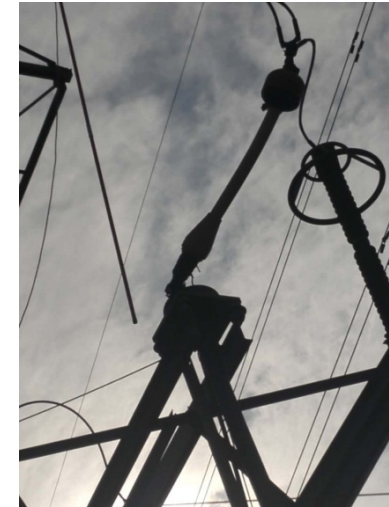
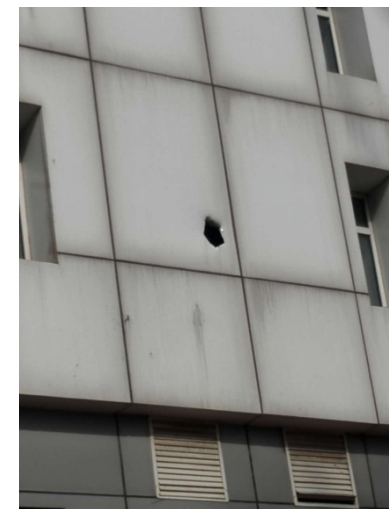
Blast of 220kV cable terminal,  
19 August, Hebei

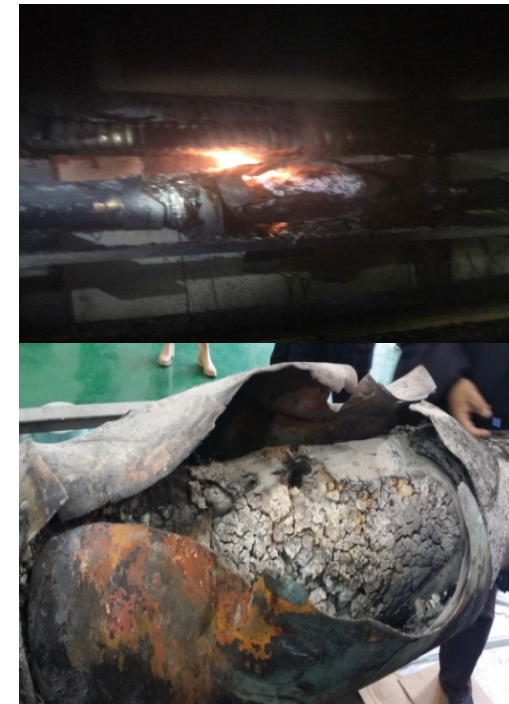
220kV Cable PMJ Breakdowns

- \* In recent 10 years, CSG had 15 220kV silicone rubber pre-molded cable joint (PMJ) breakdowns, which seriously threaten the personal safety and stable operation of power system. HV cable PMJ breakdowns were largely reported in China.
- \* The dissections of the cable PMJs mostly showed an apparent breakdown paths and electrical trees. Impurities, protrusions and voids by careless production have been assumed to be the main cause.

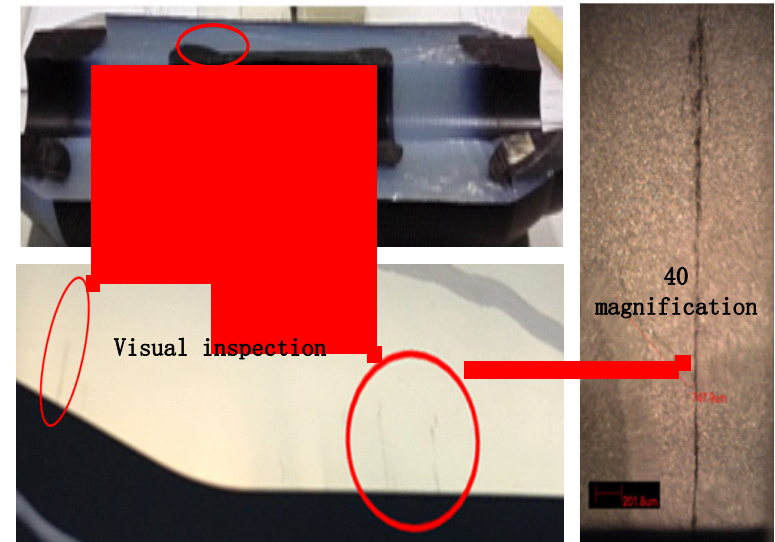
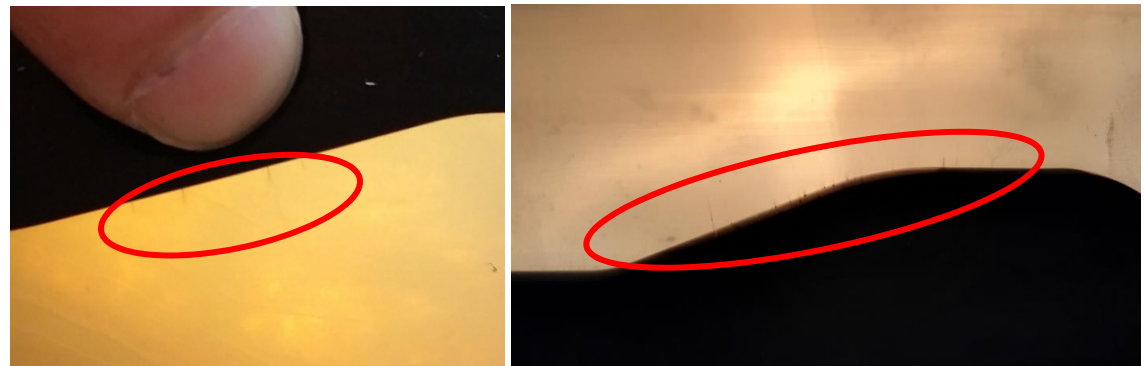
Electrical Trees at the Interface of 220kV PMJ Stress Cone

- The average protrusion size of is  $16\mu\text{m}$  (all smaller than  $50\mu\text{m}$ ).
- Electrical trees were found at the interfaces in all 3 breakdown PMJs and 2 serviced PMJs, mostly at their preliminary stage with short and straight sprout.
- Some of these small trees even did not begin from the region with the highest electrical field.

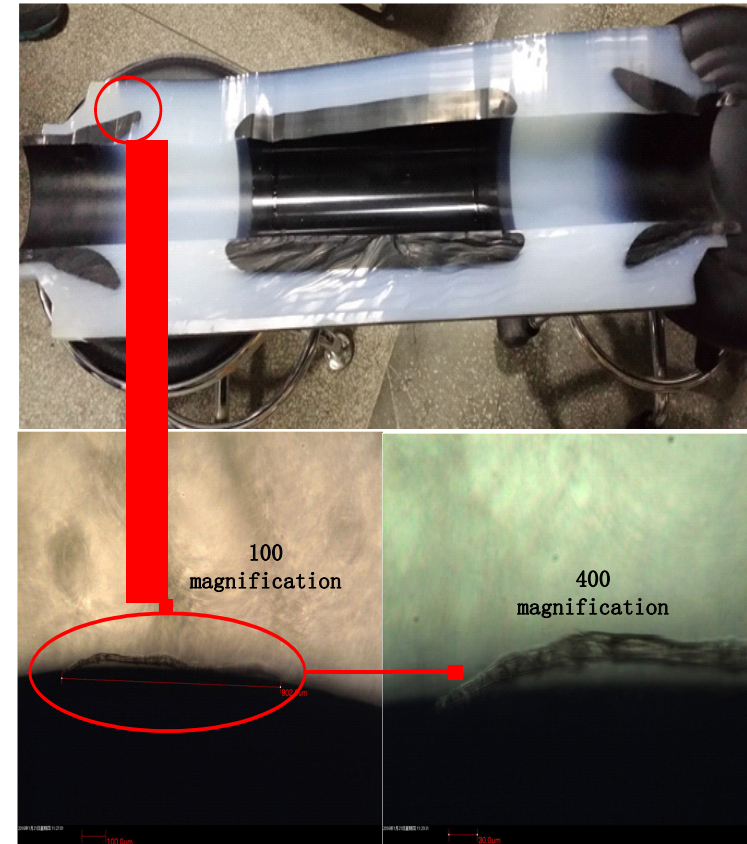
Microscopic Defects of 220kV PMJ  
Stress Cone (Manufacture B)

- Large size air voids and protrusions from 50 $\mu$ m to 900 $\mu$ m were found at the semicon-SiR interfaces.
- PD and electrical trees will initiate with such big voids and protrusions under long-term and complex operating conditions, though these “defects” could hide from routine tests before service.
- Quantitative requirement of 50 $\mu$ m was suggested to CSG technical standard for the impurity sizes.

(2) Impurities and protrusions can initiate partial discharge in long-term service. PMJs with good quality control are suggested to have impurity size less than 50 $\mu\text{m}$ .

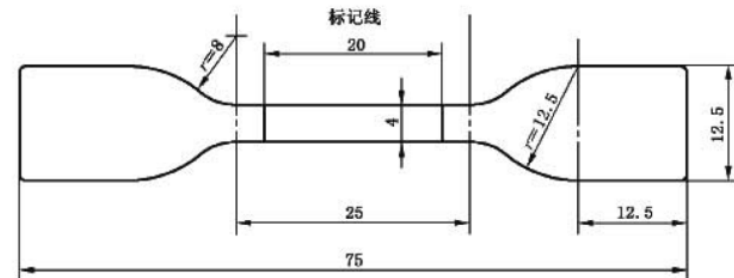
- ✧ Five dumbbell samples cut from each PMJ were tested at room temperature ( $23\pm 5^{\circ}\text{C}$ ) at the stretching rate of 200mm/min, according to GB/T 528-2009.
  - MA: (1) elongation percentage at break measurement results of 2 samples were 416% and 446%, which failed to meet China National Standard requirement of 450%; (2) tensile strength test results of 2 samples were 4.6MPa and 4.9MPa, which failed to meet China National Standard requirement of a minimum value of 5.5MPa.
  - MB: all meet the standard.

**Conclusion: MA PMJ samples exhibited an unqualified mechanical performance.**

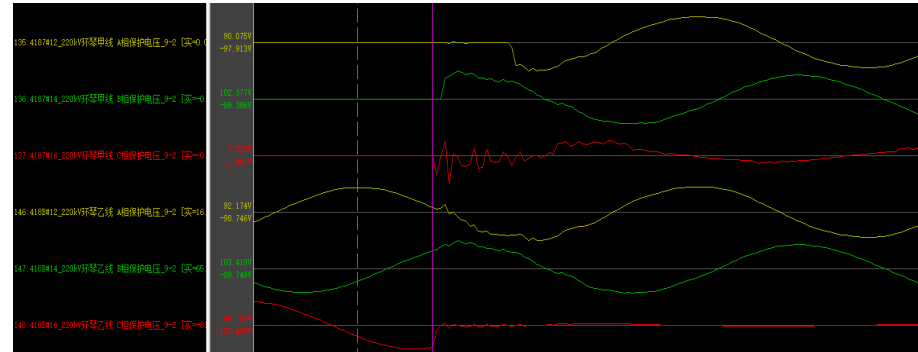
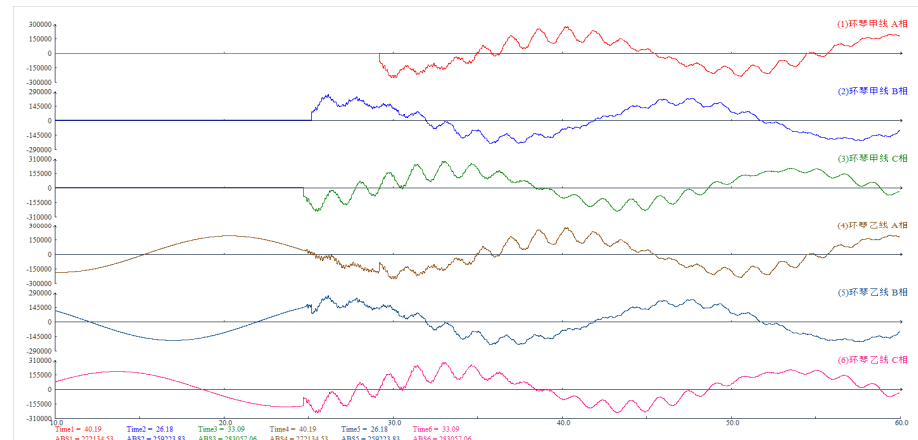
✧ The highest overvoltage along the line was  $412.4\text{kV}_{\text{peak}}$ , with the worst situation (random switching phase, no synchronization).

✧ Recorded fault oscillograph shows that the maximum transient voltage are  $283\text{kV}_{\text{peak}}$  (1.37p.u.) and  $223.1\text{kV}_{\text{peak}}$  (1.08p.u.) on the failure cable lines.
