# Experimental and Simulation Analysis of Electrical Breakdown for 220kV Silicone Rubber Pre-Molded Cable Joints

Tong Liu, Baojun Hui, Mingli Fu, Shuai Hou, Bing Luo, Guoli Wang  
Electric Power Research Institute  
China Southern Power Grid

May 2017

**INSUCON**  
2017

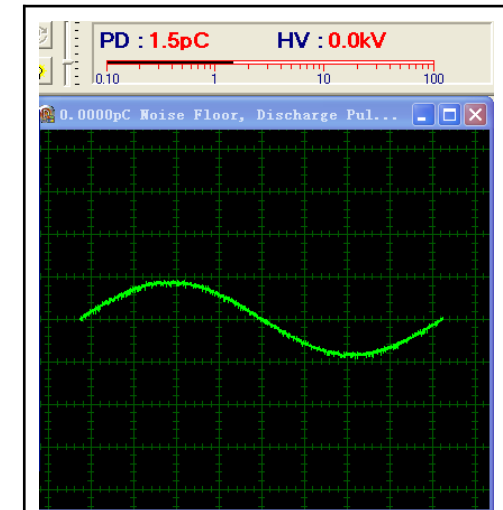
Background noise

- \* All tests were carried out on serviced PMJs of manufacture A (MA) and manufacture B (MB), according to China National Standard (GB/T 18890, 2015).
- \* The 220kV PMJs of two manufactures all passed above voltage withstand tests, and no partial discharges were detected above background 2pC.
- \* The outcomes of electrical test didn't show the evidence that the load cycling and circuit breaker switching have brought any direct impact on these PMJ failures or tree growth.

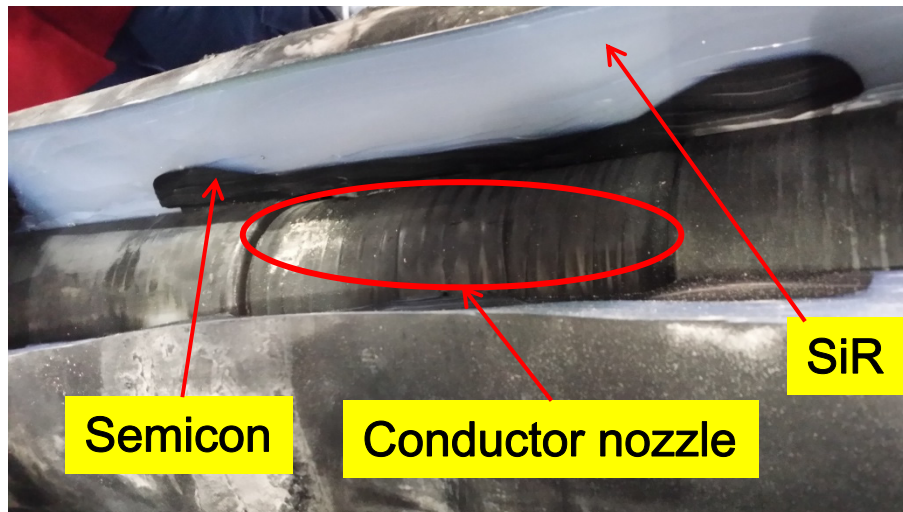
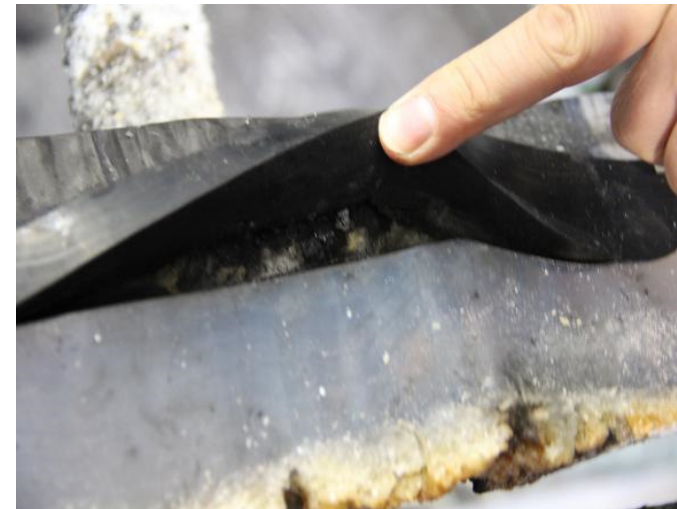
- ✧ PMJs stress cones were investigated by microscopic observation.

Silicone rubber insulation, semi-conductive material and their interfaces were checked.

- ✧ MA and MB PMJs were dissected and sliced with microscopic observation at National Key Lab in Xi'an Jiaotong University.

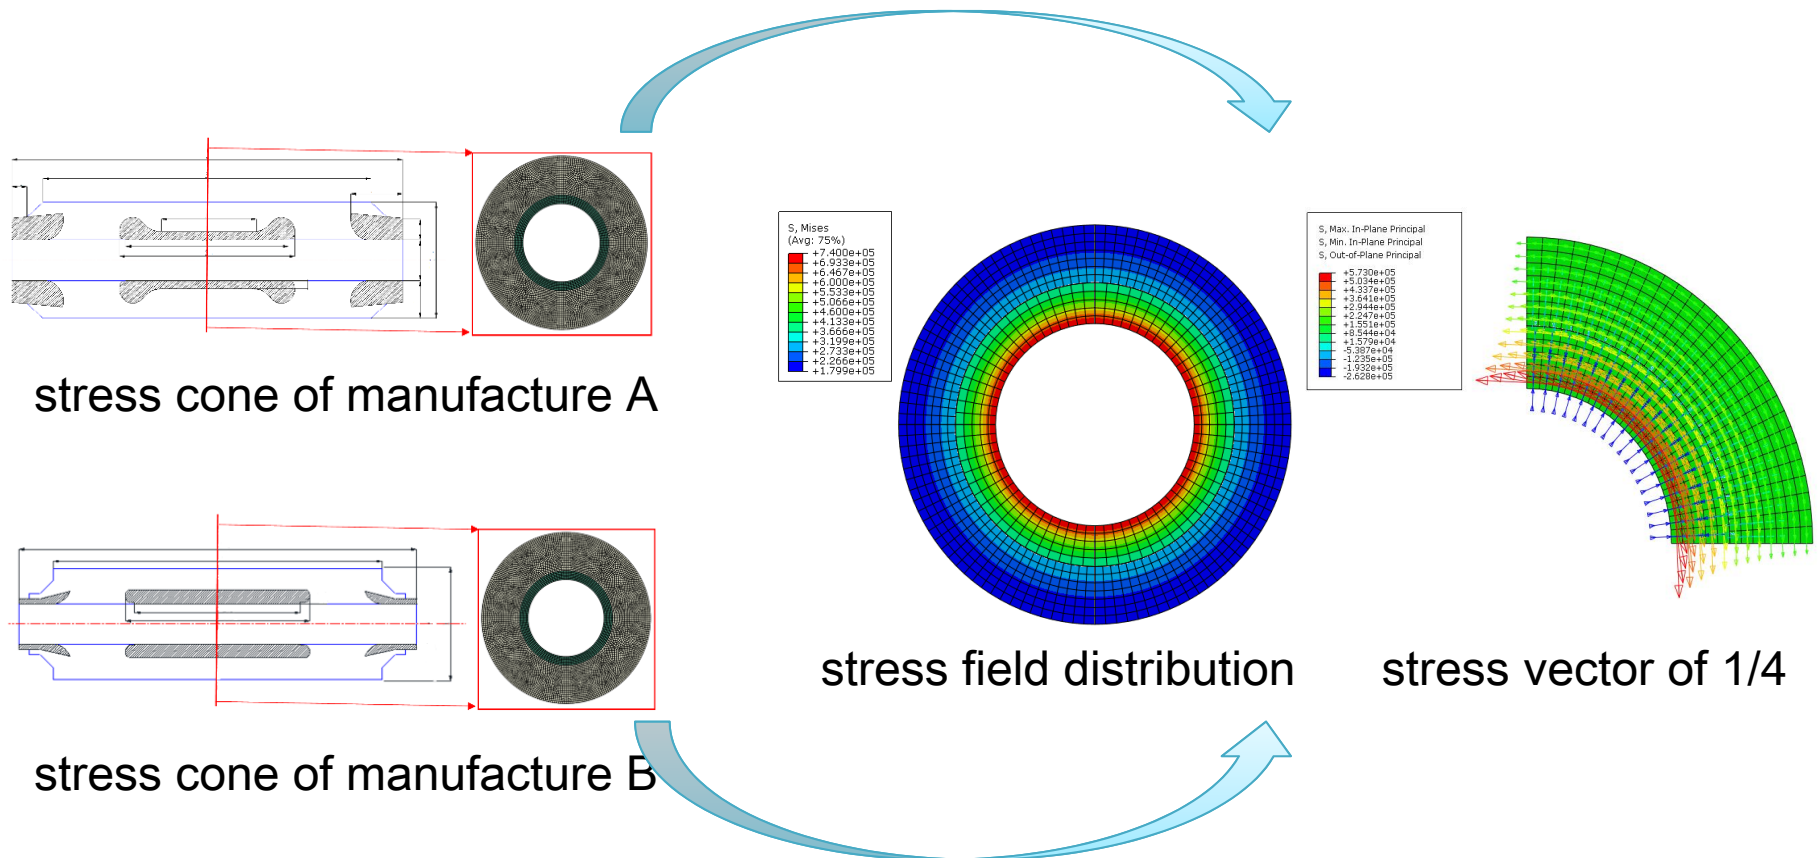
- ✧ The software ABAQUS was used for this job at the unique cross section at the very middle of PMJ's stress cone on MA and MB designs.

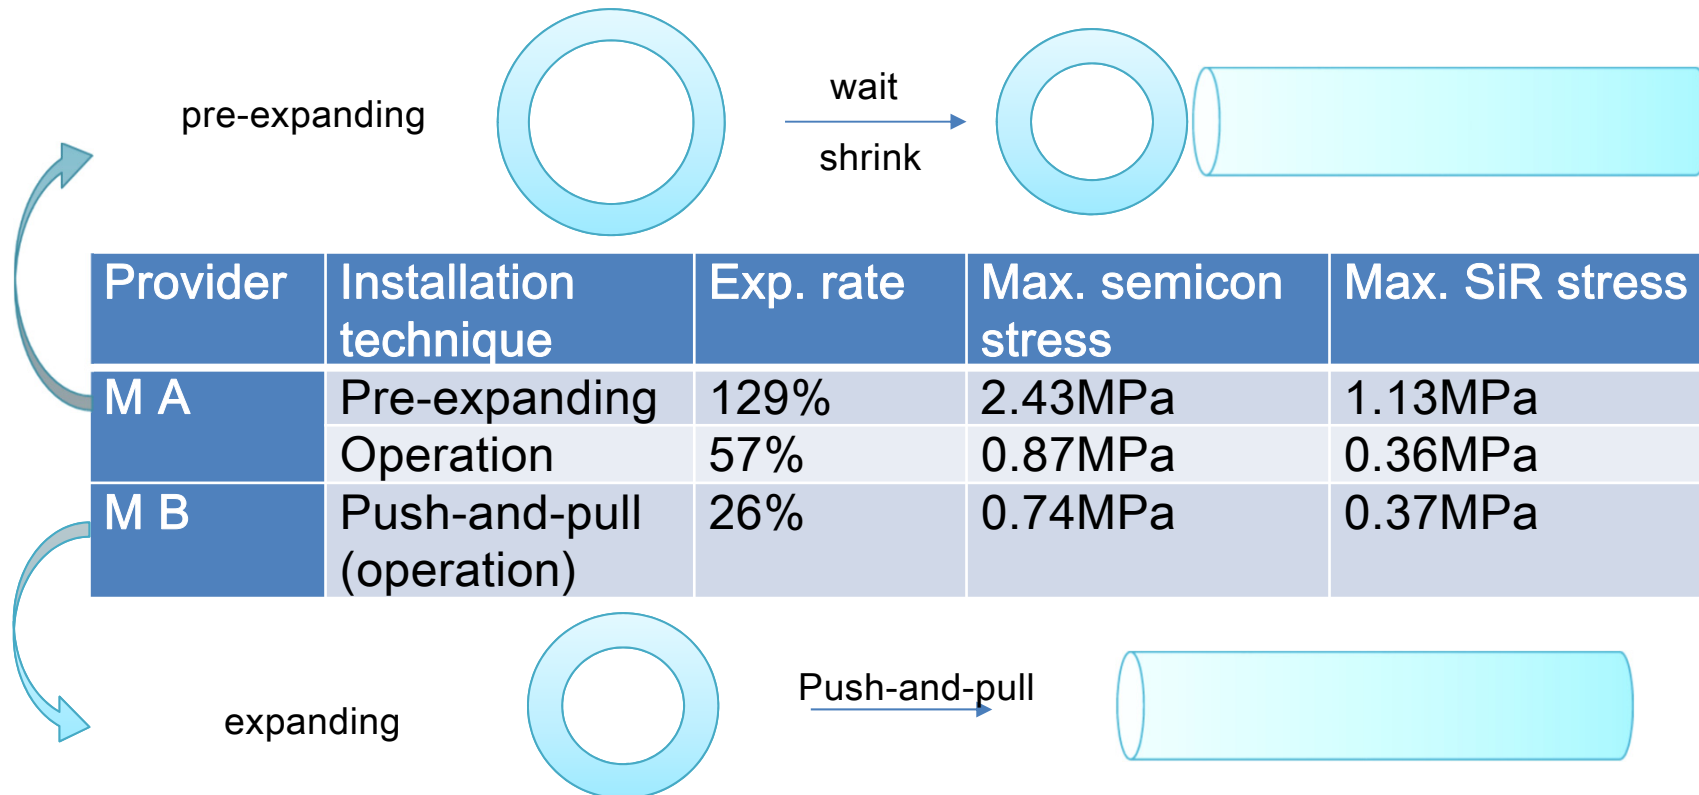
- \* Material selection, structure design and installation technique are important for the interface stress. For example, MB PMJ has bigger SiR stress with higher elastic modulus and smaller expansion rate of 26%, compared with MA.

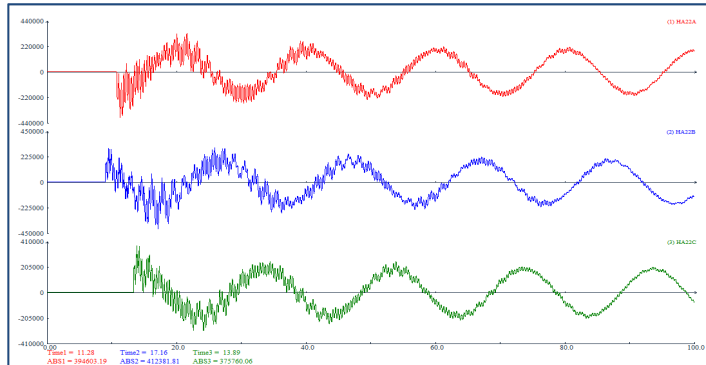
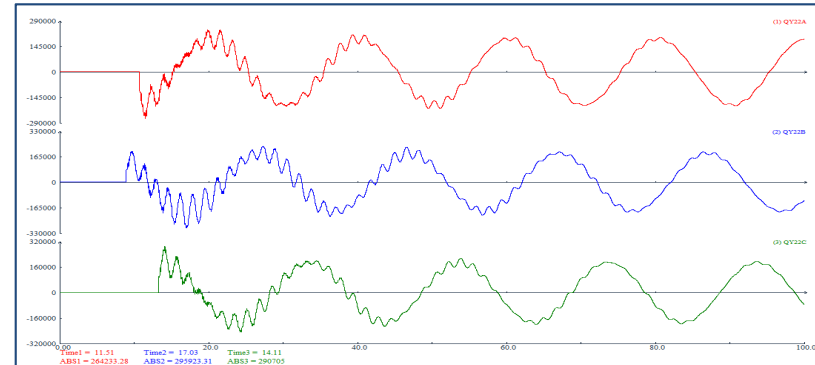
- ✧ Transient overvoltage was calculated by using EMTPE to check if the PMJ failures were caused by switching overvoltage as most of them occurred during switcher's closing.
- ✧ The cables' equivalent circuit models, including power supply, substations and arresters were built, same 220kV double circuit cable lines.

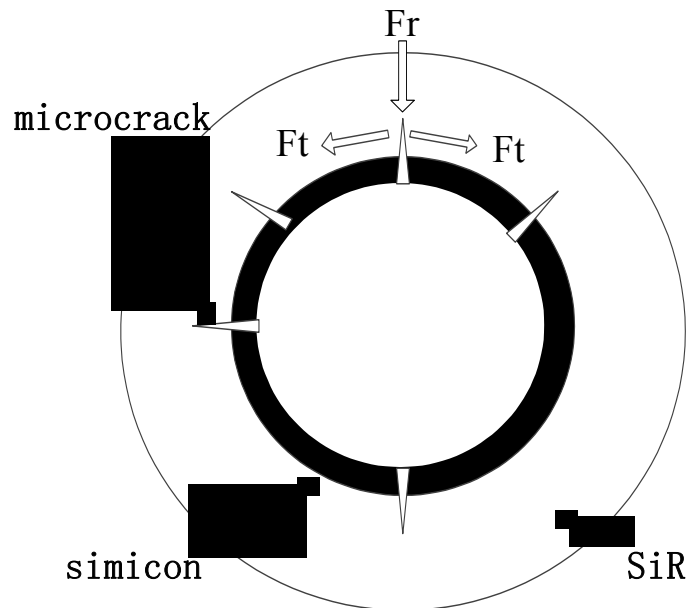
- ✧ However, there are two reasons for setting an upper limit (hypothetically 0.3MPa):
  - the elastic material, silicone rubber or EPR, may have micro-cracks that trigger electrical tree growth with partial discharge;
  - the increment of interface breakdown strength slows down with the further increasing of interfacial pressure.

switch on = last straw?
